Lessons Learned from Failed Barriers – Piper Alpha

Prepared for Presentation at American Institute of Chemical Engineers

10th Latin American Conference on Process Safety Barranquilla, Colombia September 18-20,

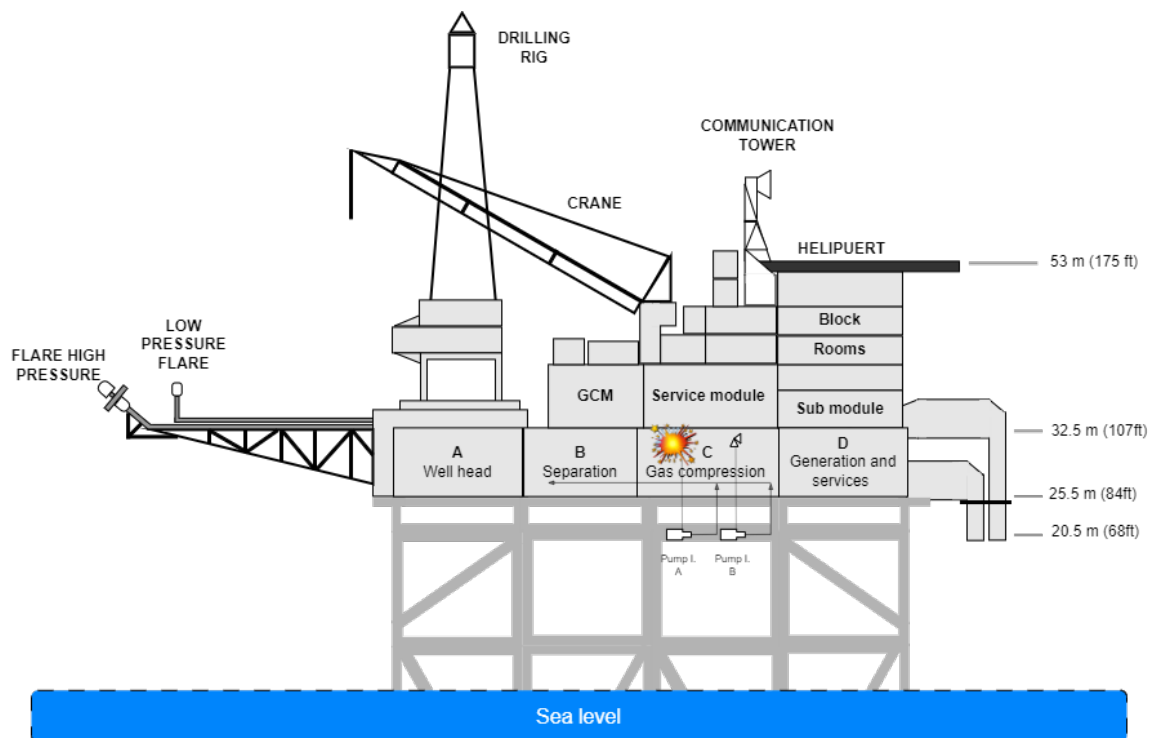
Figure 6. Piper Alpha Platform Diagram – First Explosion Location 10:00PM -View from the East

At 9:55 PM, after starting pumping with Condensate Injection pump A, gas leak alarms began to go off in module C of the production deck, followed by high pressure alarms, and at 10:00 PM An explosion occurs on the production deck of the platform, the explosion breaks the walls of module C and affects the crude oil processing section, continuing with an oil fire. The supervisor, upon recovering from the explosion, manages to activate the shutdown of the platform, interrupting production from the well; however, the Claymore and Tartan platforms, which were pumping oil to Flotta through Piper Alpha, did not stop pumping, which continued to fuel the fire. Coordination had never been developed between the platforms to deal with an emergency, nor had there been a drill to prepare for an event of this type, so there was no clear or specific condition to proceed with the interruption of pumping, a decision that implies a great loss of production for whoever takes it.

The conclusion of the public inquiry (Public Inquiry) carried out by the United Kingdom government through Lord W Cullen, concluded that the leak occurred due to the poorly secured blind flange in the intervention of the safety pressure relief valve of the condensate injection pump A, thereby generating an explosive atmosphere of propane gas that culminated in an explosion in module C. Because an extensive risk analysis was not performed during the initial design of the platform, it was not identified. The existence of an explosion was considered probable, even though methane and propane gas were processed at high pressures, only the installation of fire walls, not explosion walls, was considered.

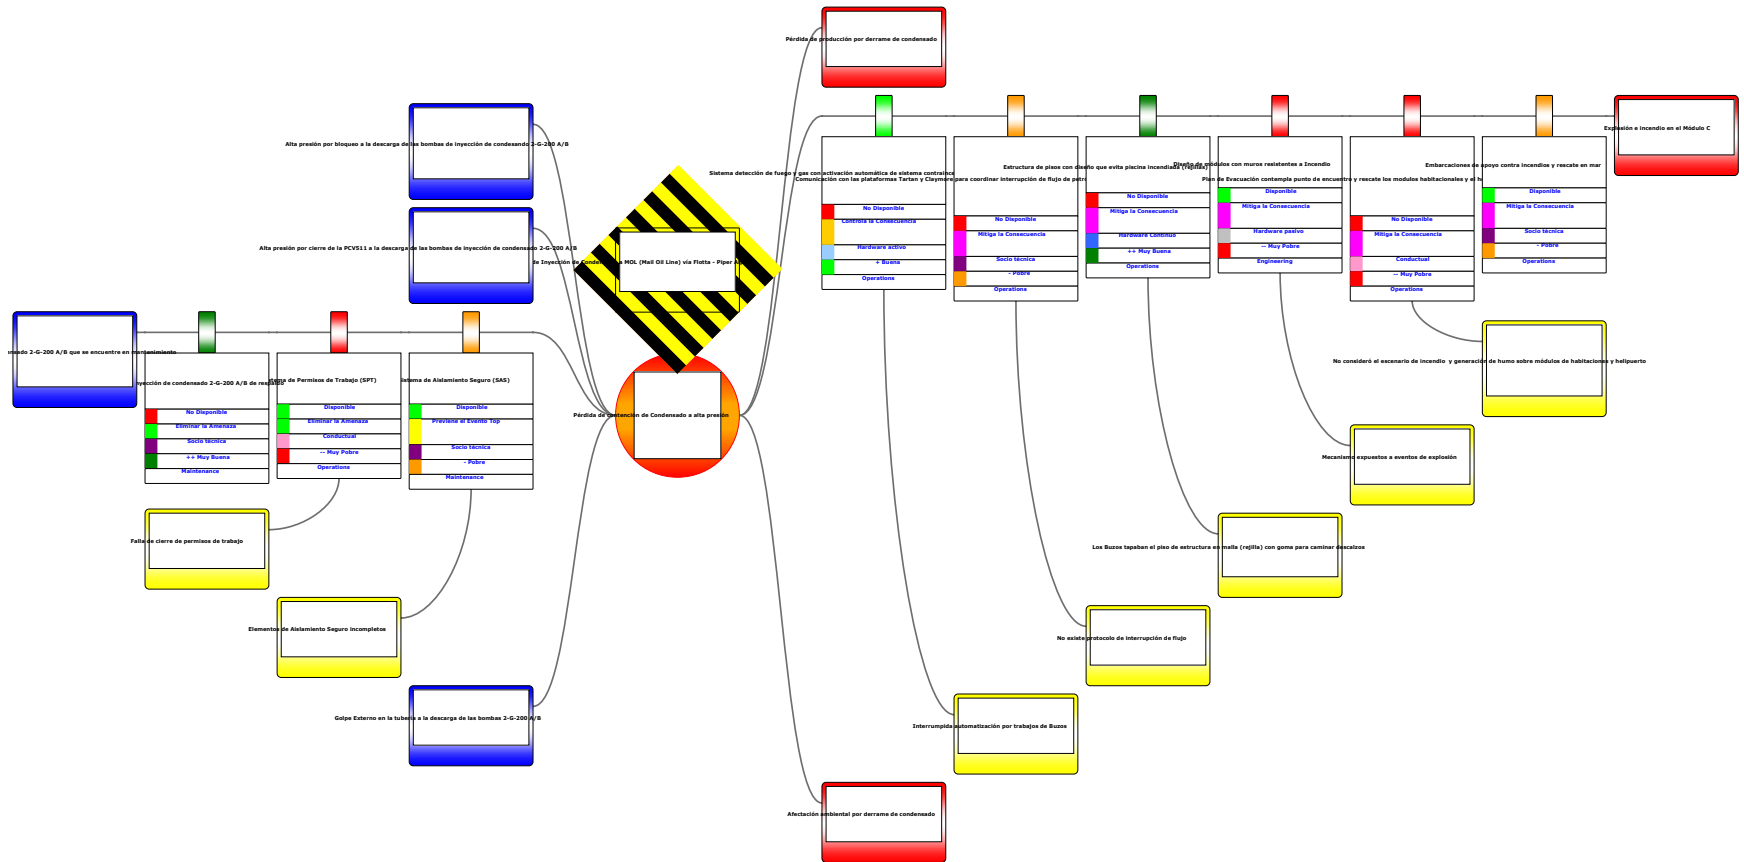
Figure 13. Bow Tie Piper Alpha

The Bow Tie diagram, Figure 13, identifies the Threat that allowed the release of the danger and the materialization of the first consequence, the first explosion in module C at the level of 68 ft (20.5m) at the relief valve. safety pressure (PSV) of the condensate injection pump A. On this path and until the last consequence, all the barriers failed, except for one (1) which was the one that allowed the rescue of the 61 survivors.

Although nine (9) barriers were found available on the Piper Alfa, three (3) preventive and six (6) mitigation, the results of a single failure allowed a “snowball” to be unleashed that led to the total destruction of the platform. and the sad death of 167 lives.

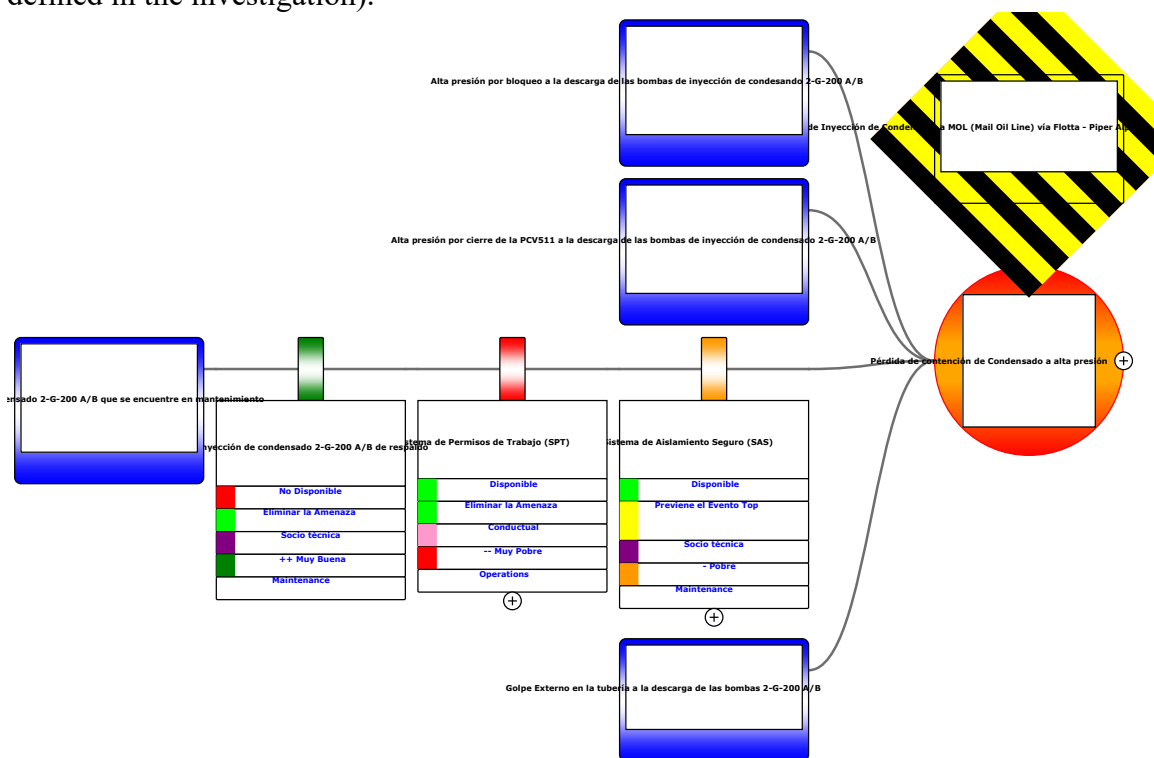
Figure 14. Characterized Preventive Barriers – Piper Alpha

As a first preventive element, there were two (2) pumps for injecting condensate into the main oil shipping line to Flotta, where there was a backup in case the pump in use failed, this barrier would have the possibility of eliminating the threatens socio-technical action. On July 6, 1988, the pump in use, 2-G-200 B, failed; however, the backup was initiating major maintenance (overhall) that would take 2 weeks, so they could not make the change immediately. Based on this condition the first barrier, with a high efficiency, was not available.

The second barrier corresponds to behavioral control regarding the work permit system. This barrier should have the ability to interrupt the sequence of events eliminating the threat, however, was not given the corresponding importance, so it became simply a piece

of paperwork requested. Due to this inadequate and unreliable system, the shift operator was partially aware of the intervention of the condensate injection pump 2-G-200 A, he identified the work permit with which he started the Overhaul of the pump that day. It only isolated it physically and electrically, but did not indicate anything about the work on the PSV valve (safety pressure relief), that activity was in another work permit format, which was not closed in an adequate way, it was not known to the operator on duty, so the failure of this system led to the alignment of the pump during maintenance. The responsibility for proper use of this important safety barrier was daily overshadowed by the importance given to production.

However, Piper Alpha had a third preventive barrier available and it corresponded to a safe isolation system where the PSV (safety pressure relief) valve was removed; its function was aimed at preventing the top event, the leak, considered for the exercise of socio-technical type, but with a high behavioral component, so it was unreliable, although available, but it took the same course as the two previous barriers, it also failed, since the maintenance contractors in charge of the PSV, different from those They intervened on the pump, confident in the physical and energy insulation of the pump, they did not adequately secure the blind flange installed on the flange where they removed the PSV.

The coincidence of failures in preventive barriers, with a tiny probability, were occurring, the sequence of events was allowing the top event to occur. Finally, at 10:00 PM on July 6, 1988 in the North Sea, 5 minutes after aligning the 2-G-200 A bomb, all the gas detection alarms in Module C began to go off and The explosion occurred that began the high consequences of the disaster.

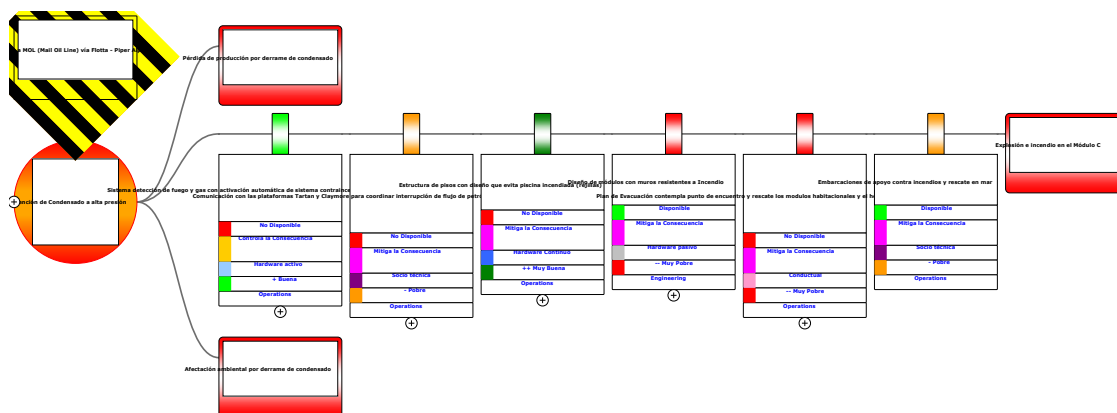
Figure 15. Characterized mitigation barriers – Piper Alpha

The first mitigation barrier identified is the fire and gas detection system with automatic activation of the firefighting system, its function is to control the consequence, type of active hardware with good effectiveness, since it covers the entire process area and would support with the cooling of the equipment and structures, however, due to the explosion the electrical systems were deactivated and the backup pumping system with diesel is not available, since the operation authorized switching the pumps to manual to avoid affecting the divers when carried out maintenance activities.

The second mitigation barrier corresponds to the communication between the Tarta, Claymore and Piper Alpha platforms, so that, in case of emergency, mainly on the Piper Alpha, since both Claymore and Tartan sent their oil and gas production to the coast to through Piper, interrupted the flow to avoid increasing the fuel supply in the event of a fire. The function of the barrier is to mitigate the socio-technical consequence of poor efficiency since it depends on a large behavioral participation, unfortunately there was no flow interruption protocol if there was no direct indication. On the day of the disaster, Piper Alpha was unable to communicate with Tartan and Claymore, so the flow interruption occurred long after the fire.

The third mitigation barrier is the structure of the floors with a design that prevents a burning pool (grids). This condition would allow spills of flammable fluids to not be contained in the structure and radiate delicate areas of the structure or process. It is a barrier with The function of mitigating the consequence of very effective continuous hardware type, however, a very critical area, below the process modules, the floors were covered with rubber so that divers could walk barefoot when entering and leaving their work, which which allowed containing hydrocarbons that helped increase fires, explosions and weaken the structure, so the barrier was Unavailable.

The fourth barrier was identified: the evacuation plan includes the housing modules and heliport as a meeting and rescue point, which has the function of mitigating the consequence and behavioral type of very poor efficiency, since, for the event of July 6, 1988, the helipad was unavailable for the large fire and smoke above it, leading to 81 people waiting for a rescue that never came.

As the last barrier and one of the few that functioned on this fateful day, were the firefighting and sea rescue support vessels, whose function is also to mitigate the consequence, of a socio-technical type and poor effectiveness, the vessels were close and available and through All of the 61 survivors were rescued.
