Lessons Learned from Failed Barriers – Piper Alpha

Prepared for Presentation at American Institute of Chemical Engineers

10th Latin American Conference on Process Safety Barranquilla, Colombia September 18-20,

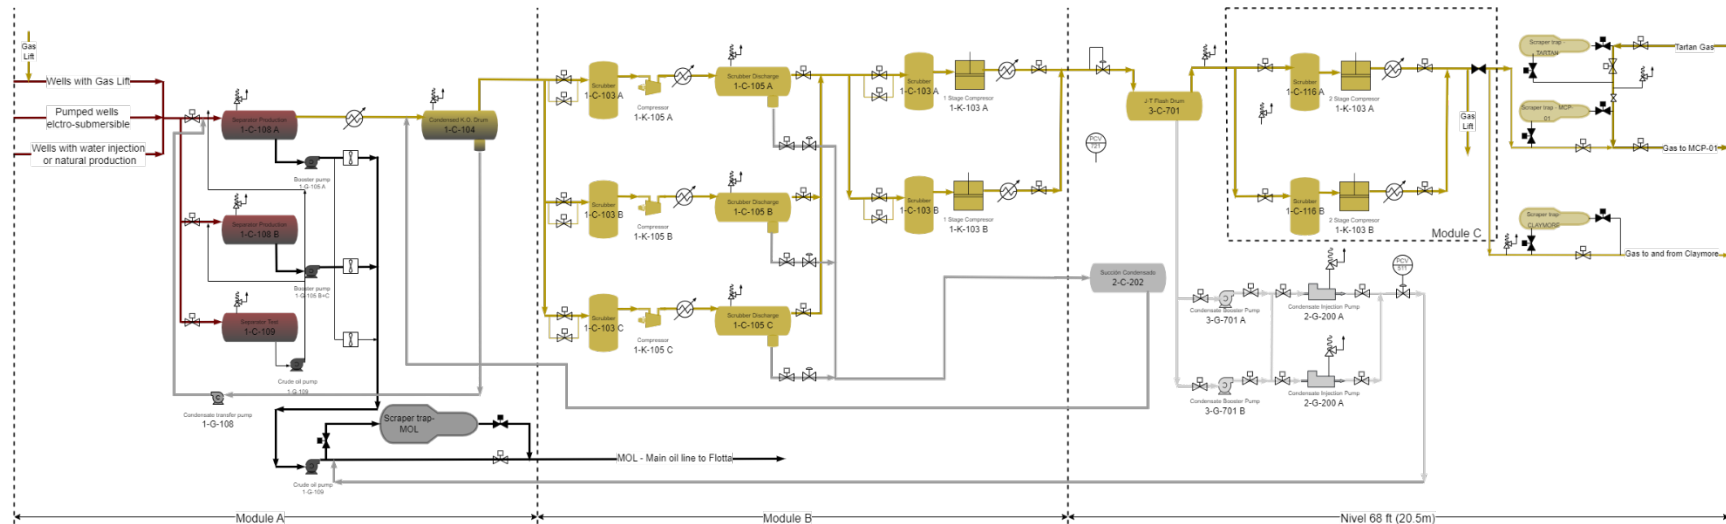
Figure 5. Process flow diagram - Piper Alpha

The condensate injection had 2 pumps to carry out this activity, 2-G-200 A and 2-G-200 B Condensate Injection pumps, 1 in operation and the other as a backup to continue the process in case of failure or if it is necessary to remove the other pump. However, that same day, Condensate Injection pump A had been electrically isolated to begin major maintenance (Overhall), so an attempt was made on several occasions to restart pump B. As the restart of the condensate injection pump was not successful, Condensate Injection B, and increasing the level of condensate in the suction container of the pumps, the operation reviewed the intervention status of the Condensate Injection pump A in the work permits issued that day in the morning, to consider its use.

The work permit for intervention on the pump did not include activities on the safety pressure relief valve of this same pump, so they saw that the only intervention on pump A was its electrical isolation and the closing of the valves. suction and discharge. They proceeded to connect it, align it and start the operation of injecting Condensate into Flotta through Pump A and did not notice the absence of the safety pressure relief valve, since its location was 5 meters above the location of the pump. and the activities on this safety valve were in another work permit left on the operator's table during the shift change, which is why he was not aware.

At 9:55 PM, after starting pumping with Condensate Injection pump A, gas leak alarms began to go off in module C of the production deck, followed by high pressure alarms, and at 10:00 PM An explosion occurs on the production deck of the platform, the explosion breaks the walls of module C and affects the crude oil processing section, continuing with an oil fire. The supervisor, upon recovering from the explosion, manages to activate the shutdown of the platform, interrupting production from the well; however, the Claymore and Tartan platforms, which were pumping oil to Flotta through Piper Alpha, did not stop pumping, which continued to fuel the fire. Coordination had never been developed between the platforms to deal with an emergency, nor had there been a drill to prepare for an event of this type, so there was no clear or specific condition to proceed with the interruption of pumping, a decision that implies a great loss of production for whoever takes it.

The conclusion of the public inquiry (Public Inquiry) carried out by the United Kingdom government through Lord W Cullen, concluded that the leak occurred due to the poorly secured blind flange in the intervention of the safety pressure relief valve of the condensate injection pump A, thereby generating an explosive atmosphere of propane gas that culminated in an explosion in module C. Because an extensive risk analysis was not performed during the initial design of the platform, it was not identified. The existence of an explosion was considered probable, even though methane and propane gas were processed at high pressures, only the installation of fire walls, not explosion walls, was considered.
